Inspection Report

Property Address:
33977 Stara Lane
Hendersonville WI

Ultimate Home Inspection

Date: 3/30/2012	Time:	Report ID: 33977staralane
Property: 33977 Stara Lane Hendersonville WI	Customer: Danica Sample	Real Estate Professional:

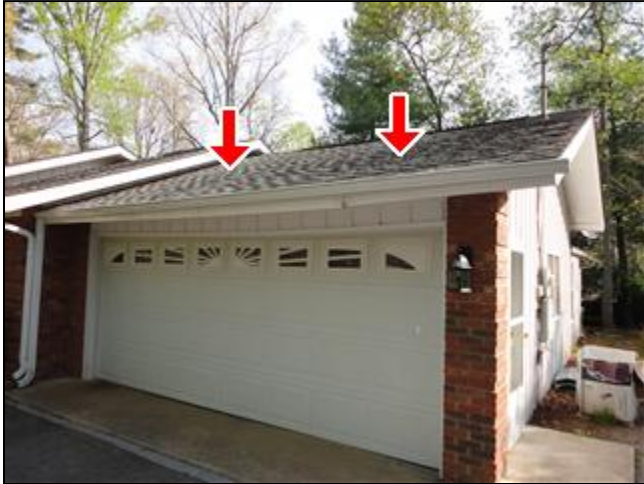
1.0 Item 1(Picture)

**1.0** (1) Evidence of a leak in the Den below corresponds with the middle skylight roof and flashing area. Repairs are needed. Recommend a qualified contractor inspect further and repair as needed.

🔧 (2) The roof covering was installed improperly above garage. Roof sheathing needs to be replaced in this area. This will involve some shingle replacement. A qualified contractor should inspect and repair as needed.

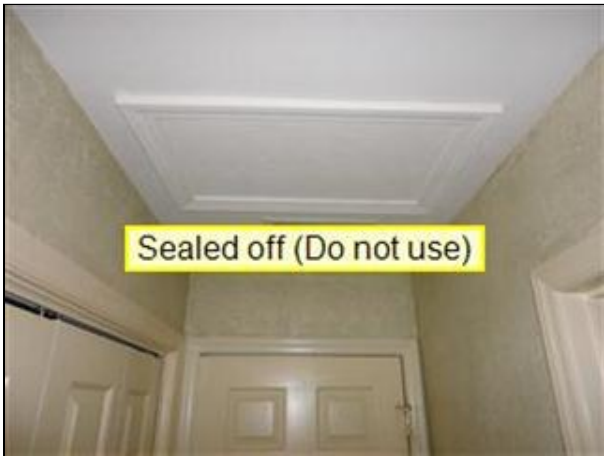
1.5 Item 1(Picture)

1.5 No longer an attic access. Use the pull down stairs at garage.

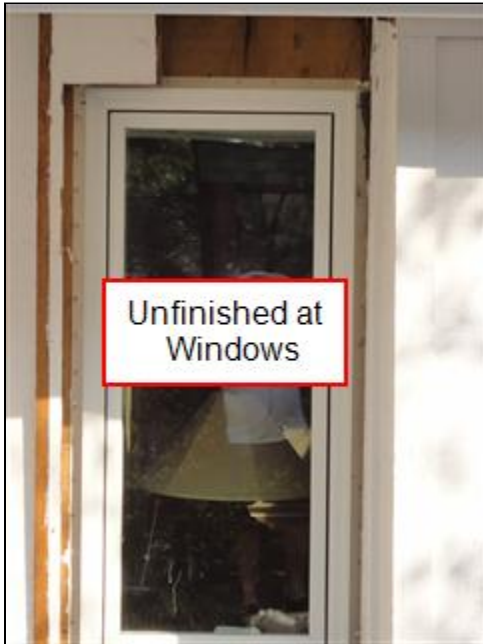
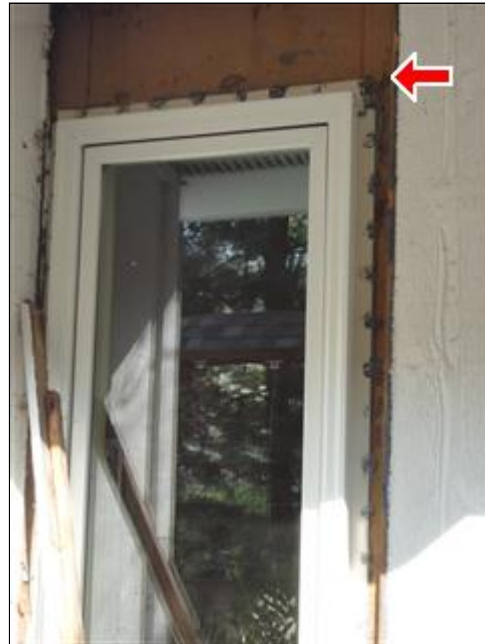
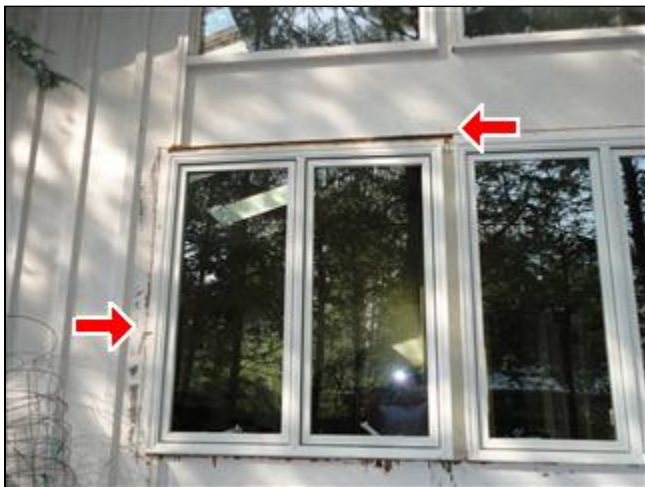
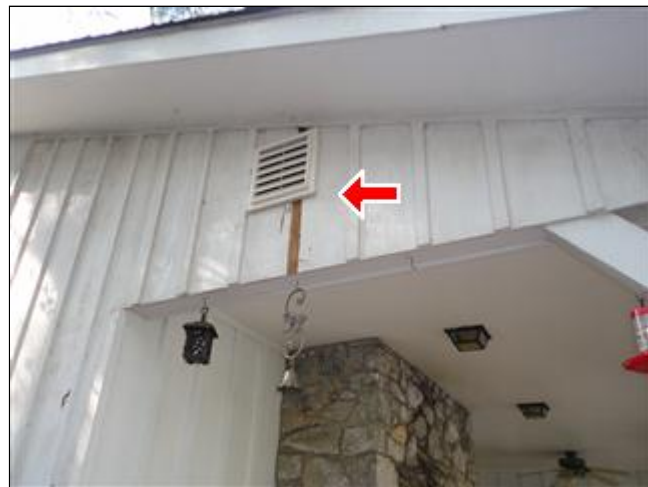
🔧 **2.0** The Wood siding at the right side (facing front) and rear of home is missing or incomplete at time of inspection around new premium windows that have recently been installed. I did not inspect the installation of siding at this location. A qualified contractor should inspect and repair as needed. The siding will need prep and paint.

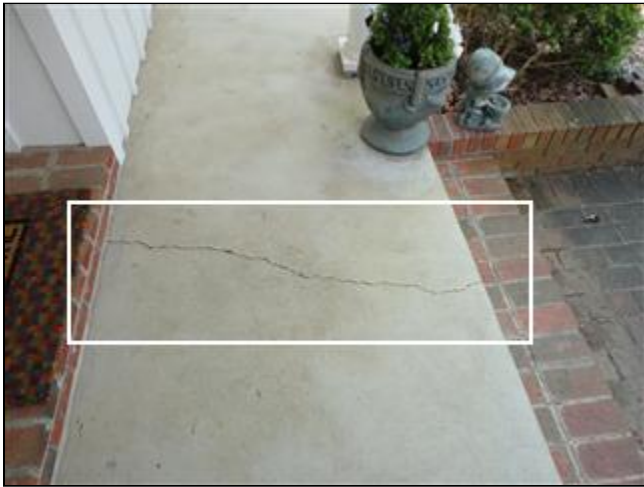
2.4 Item 6(Picture)

(3) Concrete is cracked at front entrance of home. Appears to only affect the slab itself and is more cosmetic.

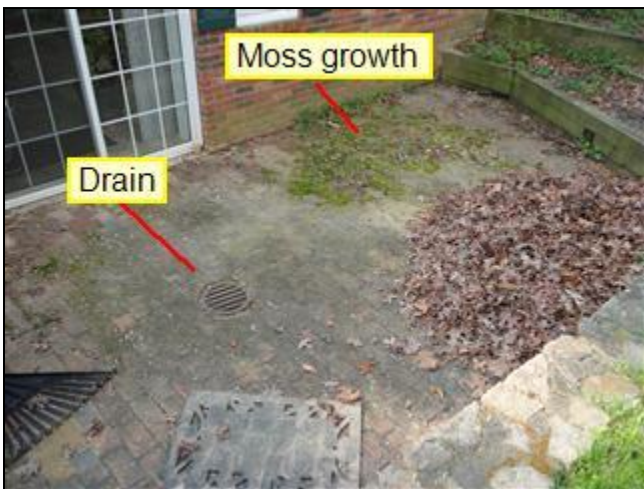
2.4 Item 7(Picture)

🔧 (4) The brick floor on the patio at the left side (facing front) has deteriorated mortar or grout, and is loose and uneven in areas. Water can cause further deterioration if not repaired and sealed properly. A qualified contractor should inspect and repair as needed.

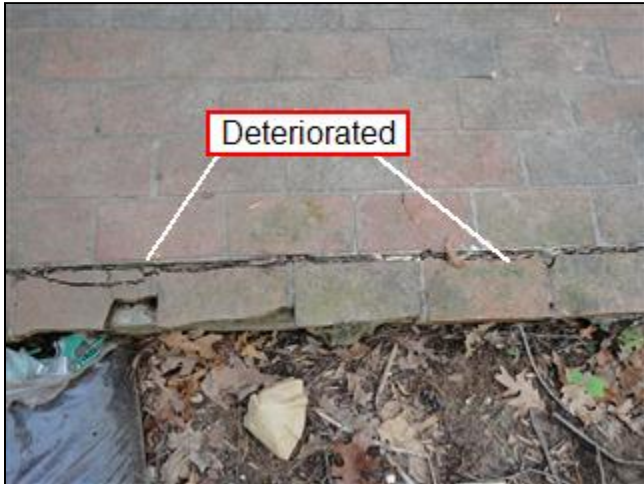
2.4 Item 8(Picture)

🔨 (5) The brick floor on the patio at the rear of home is old and deteriorated. A general replacement is likely. A qualified contractor should inspect and repair as needed.

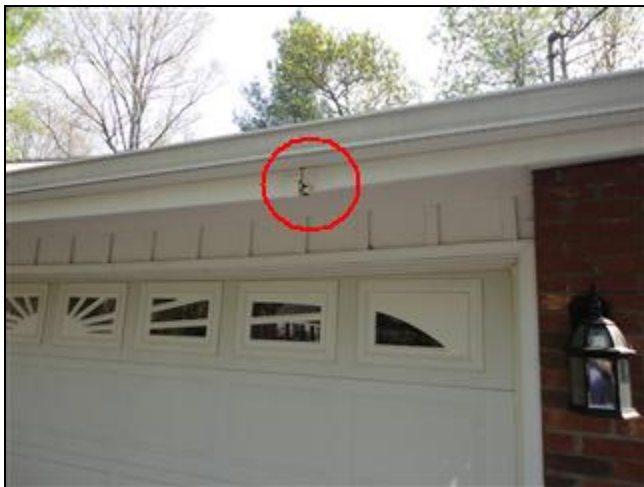
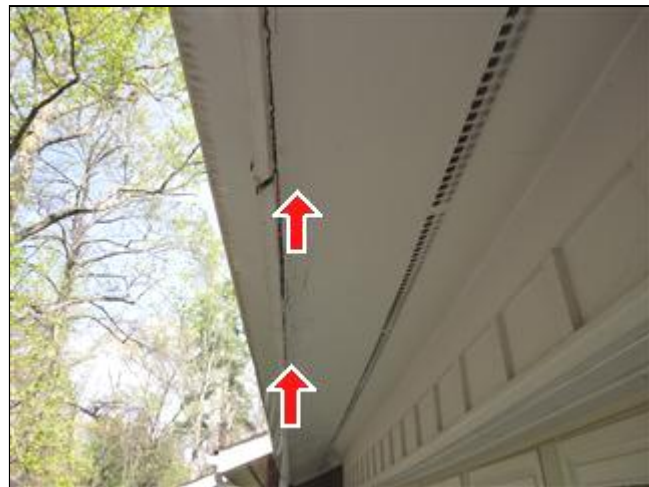
🔨 2.5 (1) The wood fascia and soffit panels at eave on the front of home above garage are deteriorated. Repairs are needed to roof covering as well. A qualified contractor should inspect and repair as needed.

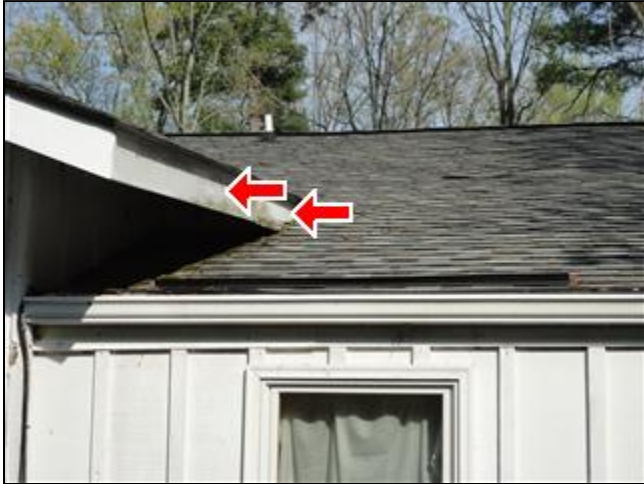
2.5 Item 3(Picture)

🔧 (2) The wood fascia at eave on the right side (facing front) is deteriorated. This is a small repair. A qualified contractor should inspect and repair as needed.

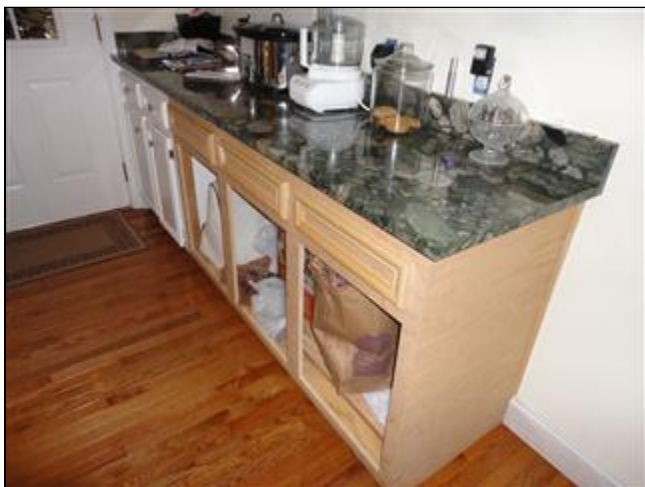
🔧 4.5 Base Cabinetry and trim at wall cabinet are unfinished at kitchen.

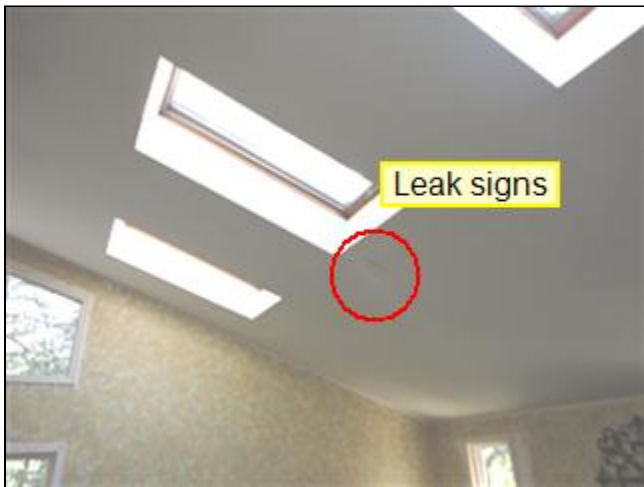
5.0 Item 1(Picture)

5.0 (1) The Sheetrock on the ceiling reveals a water stain indicating a leak did or still exists at the Den. Repairs are needed. A qualified contractor should inspect and repair as needed (See Roof Coverings).

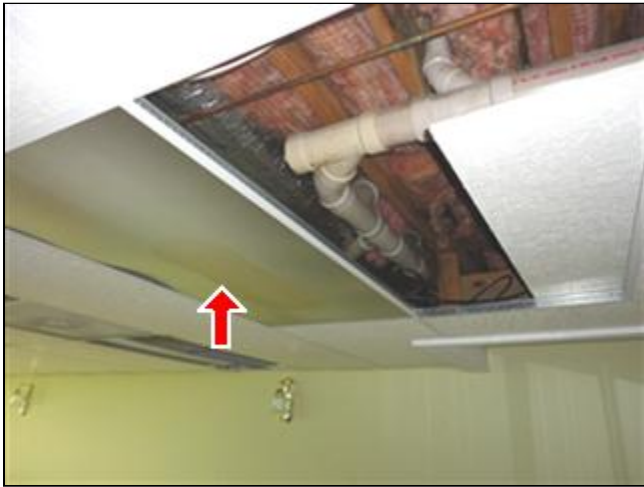
5.0 Item 2(Picture)

🔧 (2) Water stain on ceiling panel lower level indicates plumbing leak.

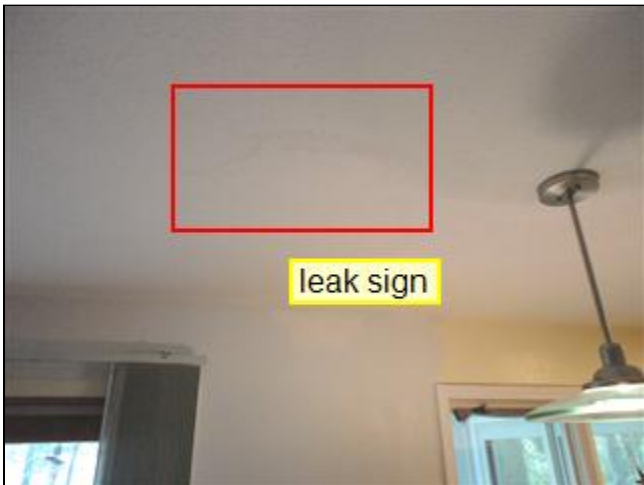
🔧 (3) The Drywall on the ceiling reveals a water stain indicating a leak did or still exists at the Dining Room. Repairs are needed. A qualified contractor should inspect and repair as needed.

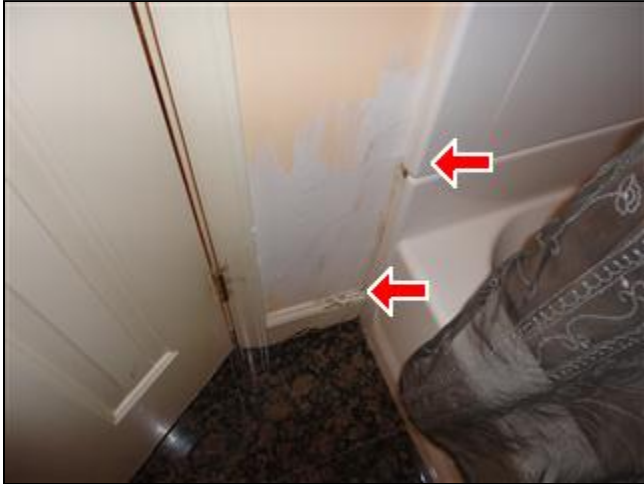
5.1 Item 1(Picture)

🔧 (2) The Wall at the bathtub is deteriorated and needs repair or replacement. The wall board and framing may need repair (not visible). I recommend repair or replace using a qualified contractor.

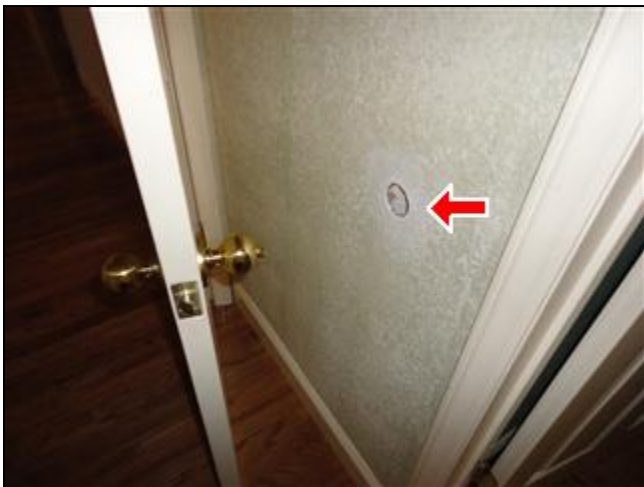
5.1 Item 2(Picture)

🔧 (3) The sheetrock on the wall is dented or damaged from door knob at the hallway. While this damage is cosmetic, it needs to be repaired. A qualified contractor should inspect and repair as needed.

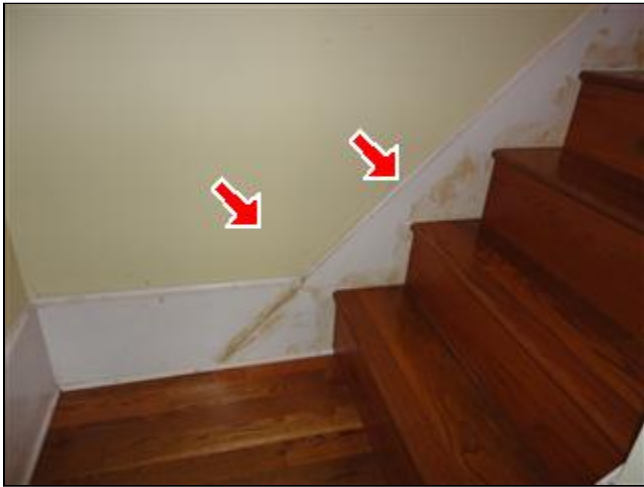
5.1 Item 3(Picture)

🔧 (4) Stair cover trim is unfinished needs prep and paint at stairs.

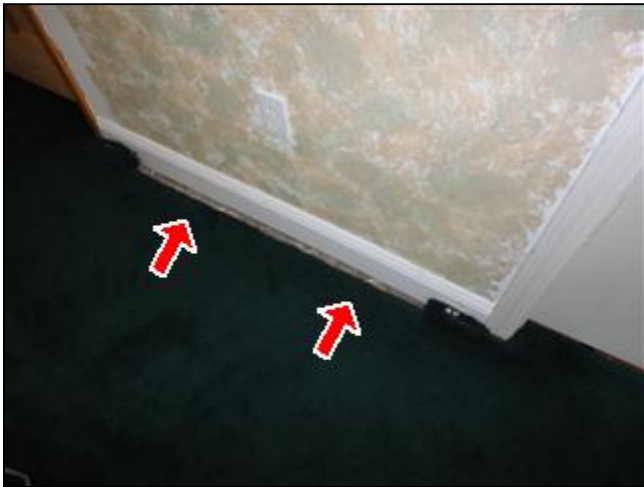
5.2 Item 1(Picture)

🔧 5.2 Carpet is loose or cut short from where electric baseboard use to be in areas around the perimeter of the Den.

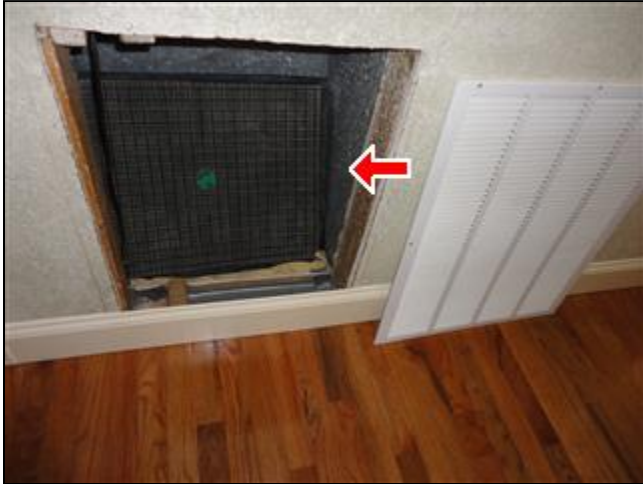
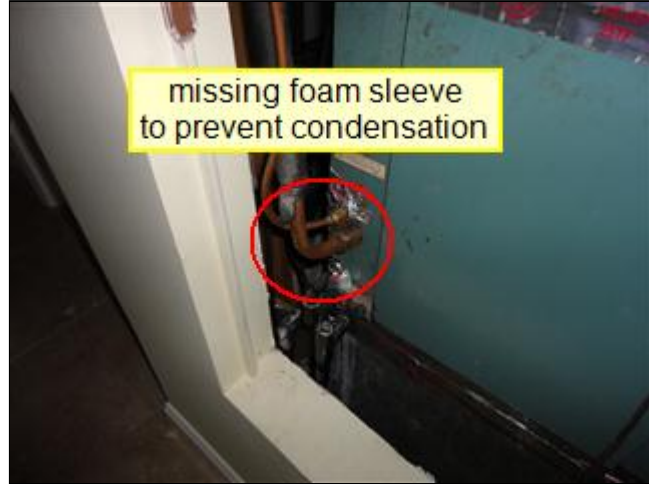
10.3 The washable filter is dirty. The filter needs to be cleaned. Recommend foil taping the filter for a better seal. See Video. Foam sleeve missing at suction line creates condensation and drips water.

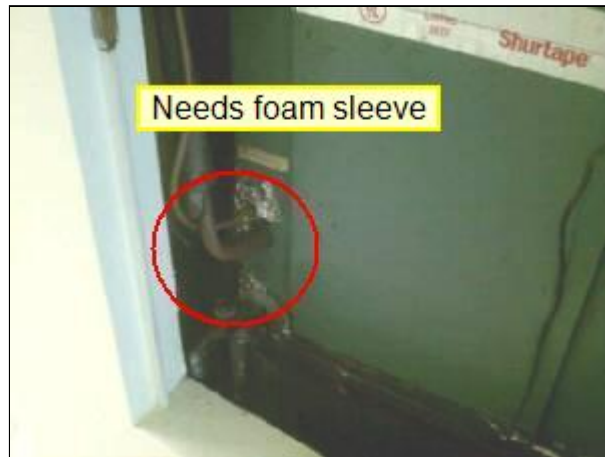
10.8 Item 2(Picture)

10.8 Air handler and heat pump is old but appears to be working properly. Foam sleeve on suction line is not covering copper line and condensation can drip.
